Highly Reliable System-on-Chip using Dynamical Reconfigurable FPGAs

Boyang Du
David Merodio Codinachs
Luca Sterpone

Politecnico di Torino CAD Group - Dipartimento di Automatica e Informatica
Torino - Italy

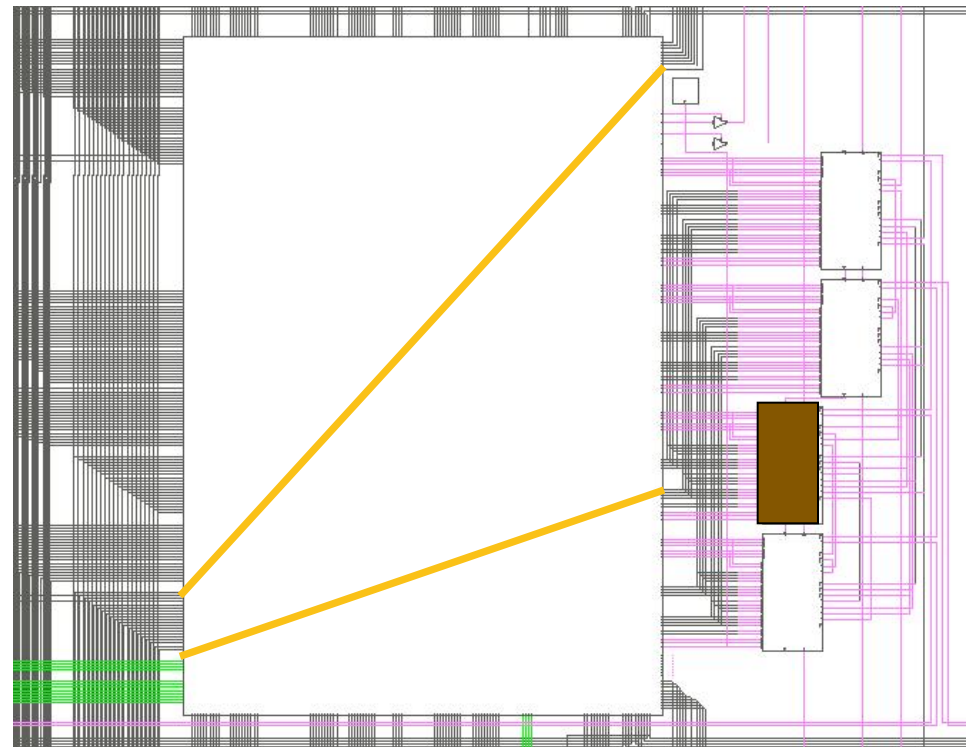
- The original netlist

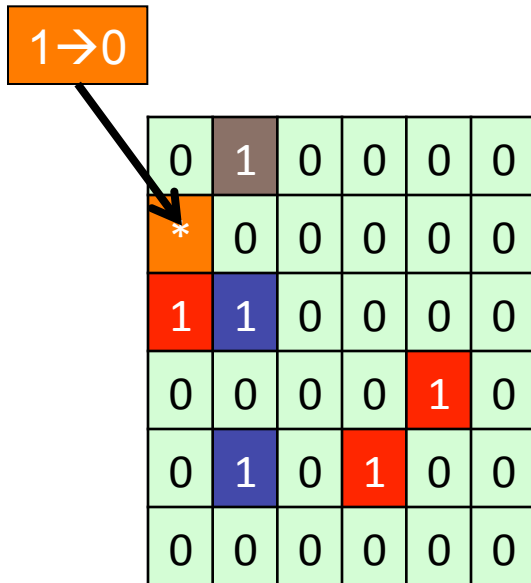
□ The bitstream

□ The corrupted netlist

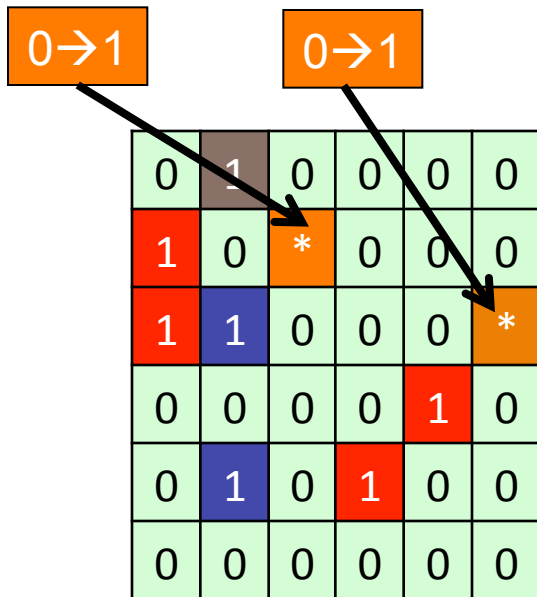
SEU scenario: accumulation of 2-bit

□ The corrupted netlist

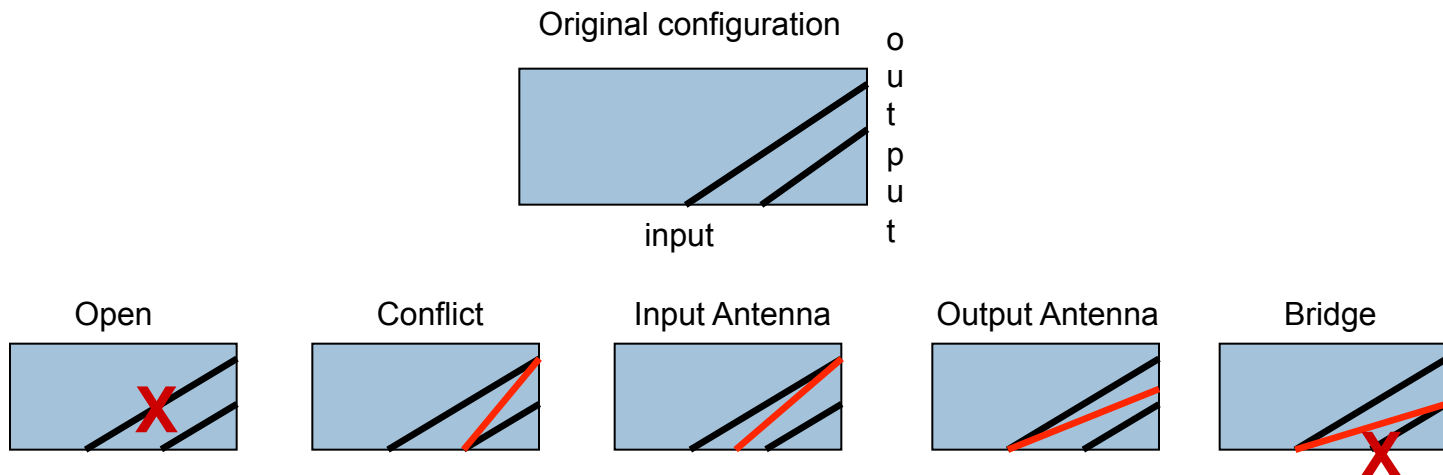
- SEU within the configuration memory
 - FPGA resource not affected : **NO ERROR**
 - FPGA resource affected : **ERROR**
- SEU induced architectural modification
 - **Logic Element: LUT, MUX, FF Config**
 - **Interconnections: Switchbox**

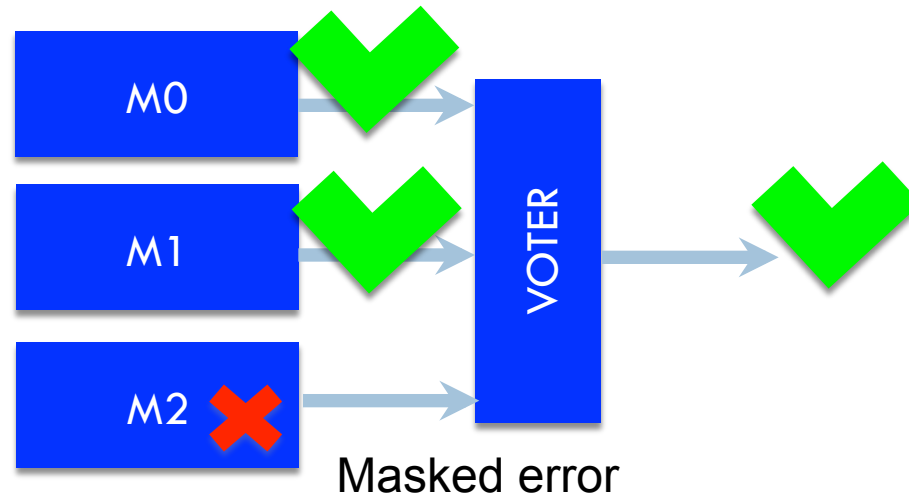
- The application of Netlist-based TMR and scrubbing is an effective solution
 - ▣ Drawbacks: power consumption and functional availability

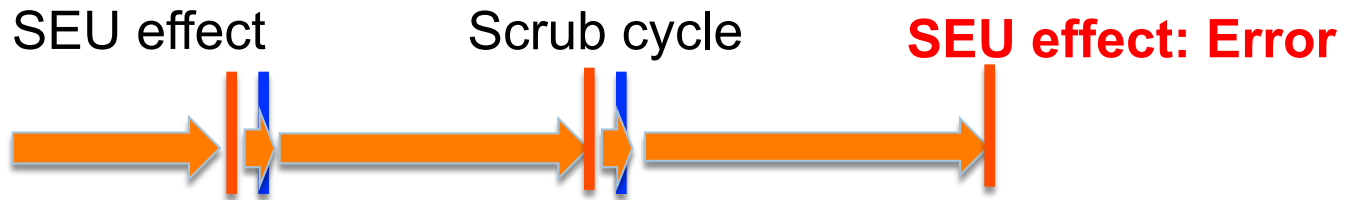
**with
scrubbing**

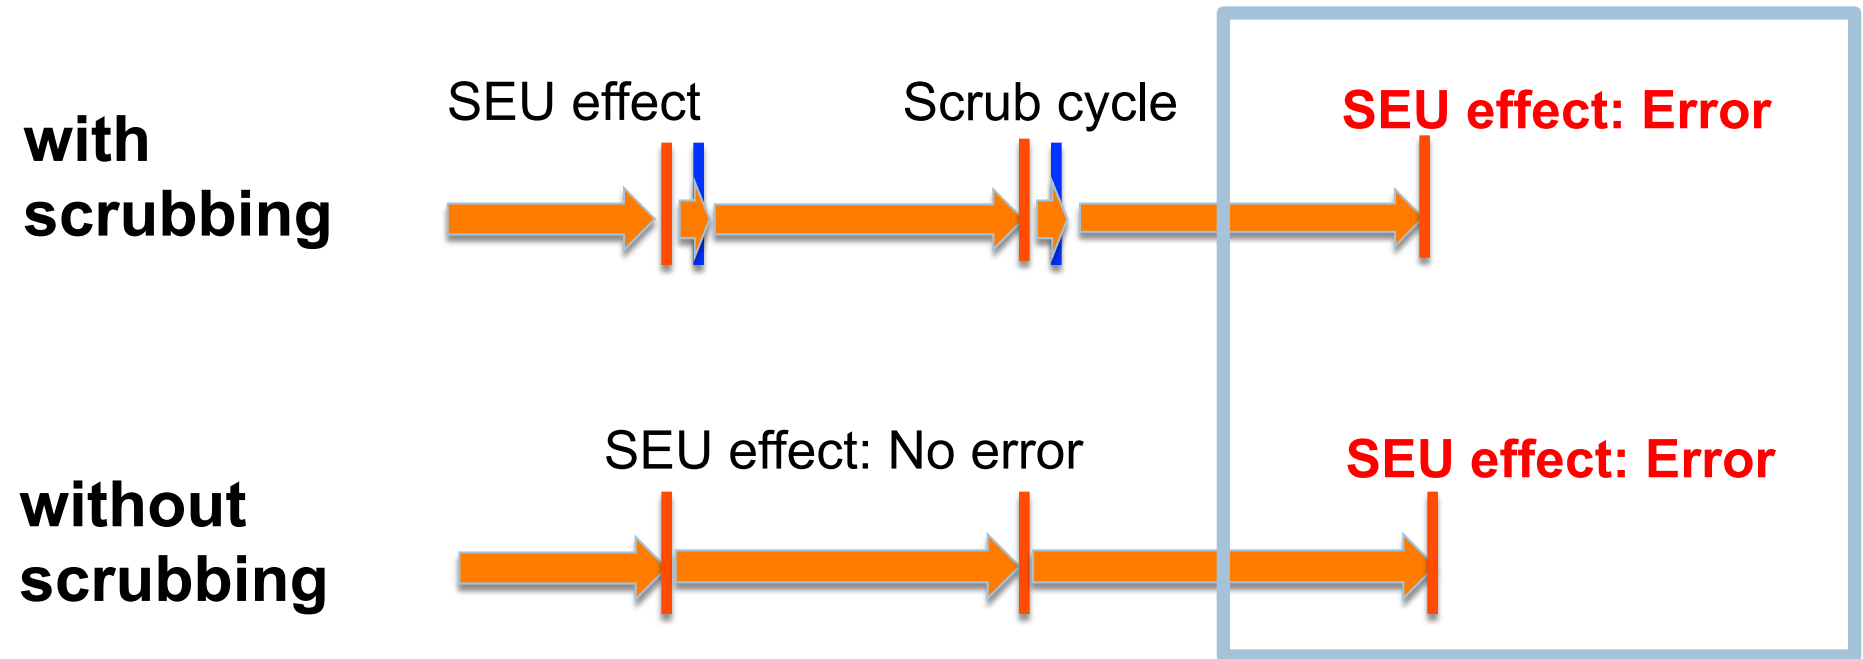
Errors affecting the circuit outputs happen at the same time

- **Probability of SEU location**
- Avoid of SPFs: **TMR is a MUST**

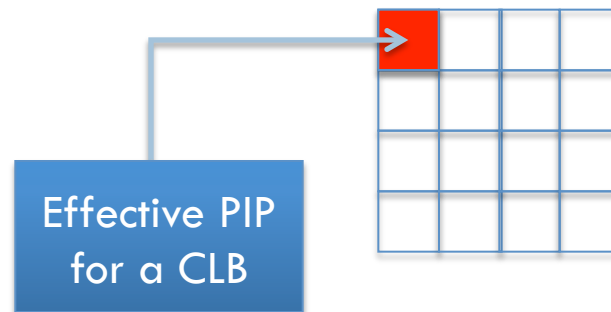
- The decoding is performed on effective PIPs
- The whole PIP coding is generated calculating the configuration memory offset between different CLBs

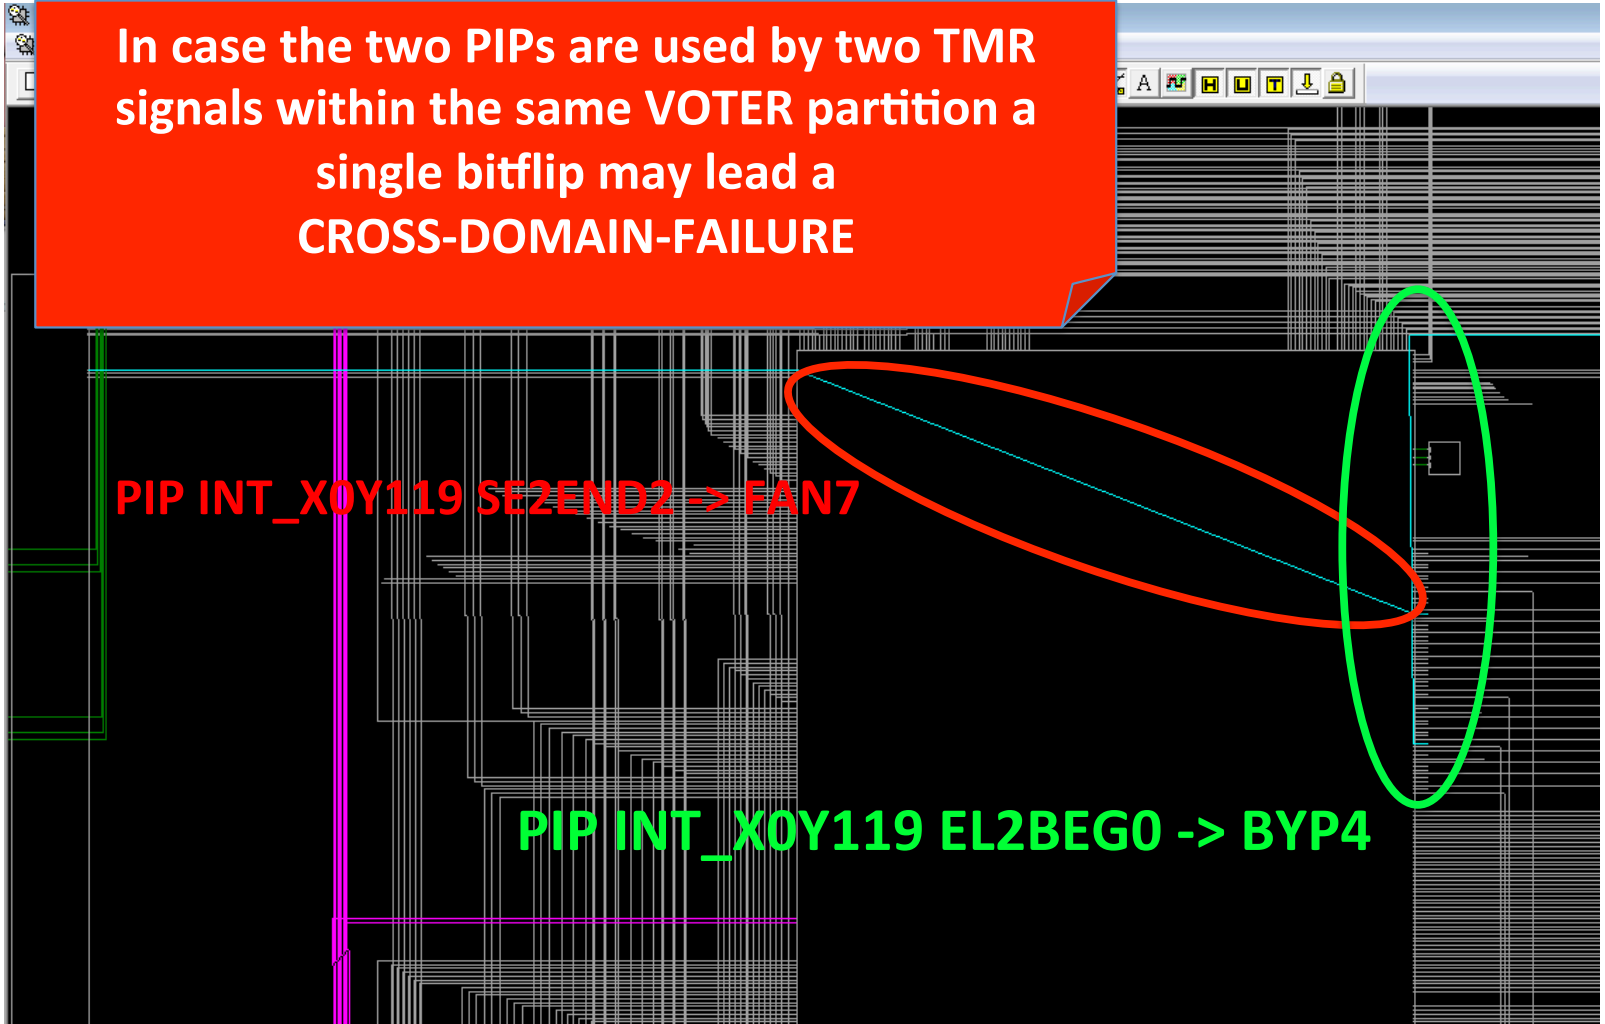
In case the two PIPs are used by two TMR signals within the same VOTER partition a single bitflip may lead a CROSS-DOMAIN-FAILURE

PIP INT_X0Y119 SE2END2 -> FAN7

PIP INT_X0Y119 EL2BEG0 -> BYP4

An upset in the bit 3.693.214 (1->0) may open two different PIPs

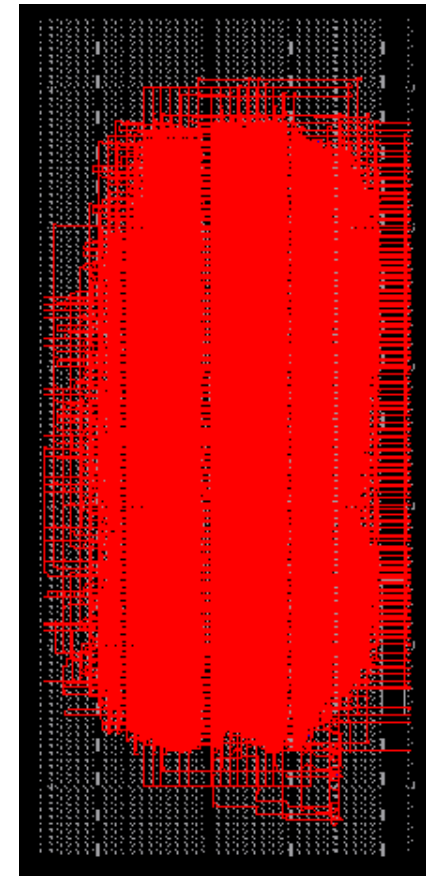
B13x30 - VP-XTMR

The Layout is complementary
with Isolation Design Flow

- 3 different design topologies have been tested at Los Alamos
 - **PLAIN** : b13x30 without any type of hardening
 - **XTMR**: Triple Modular Redundancy version with converge option of outputs pins using Xilinx TMRTool 2.1.76
 - **VP-XTMR**: Hardening version of XTMR with replacement constraints generated byVERI-Place tool.

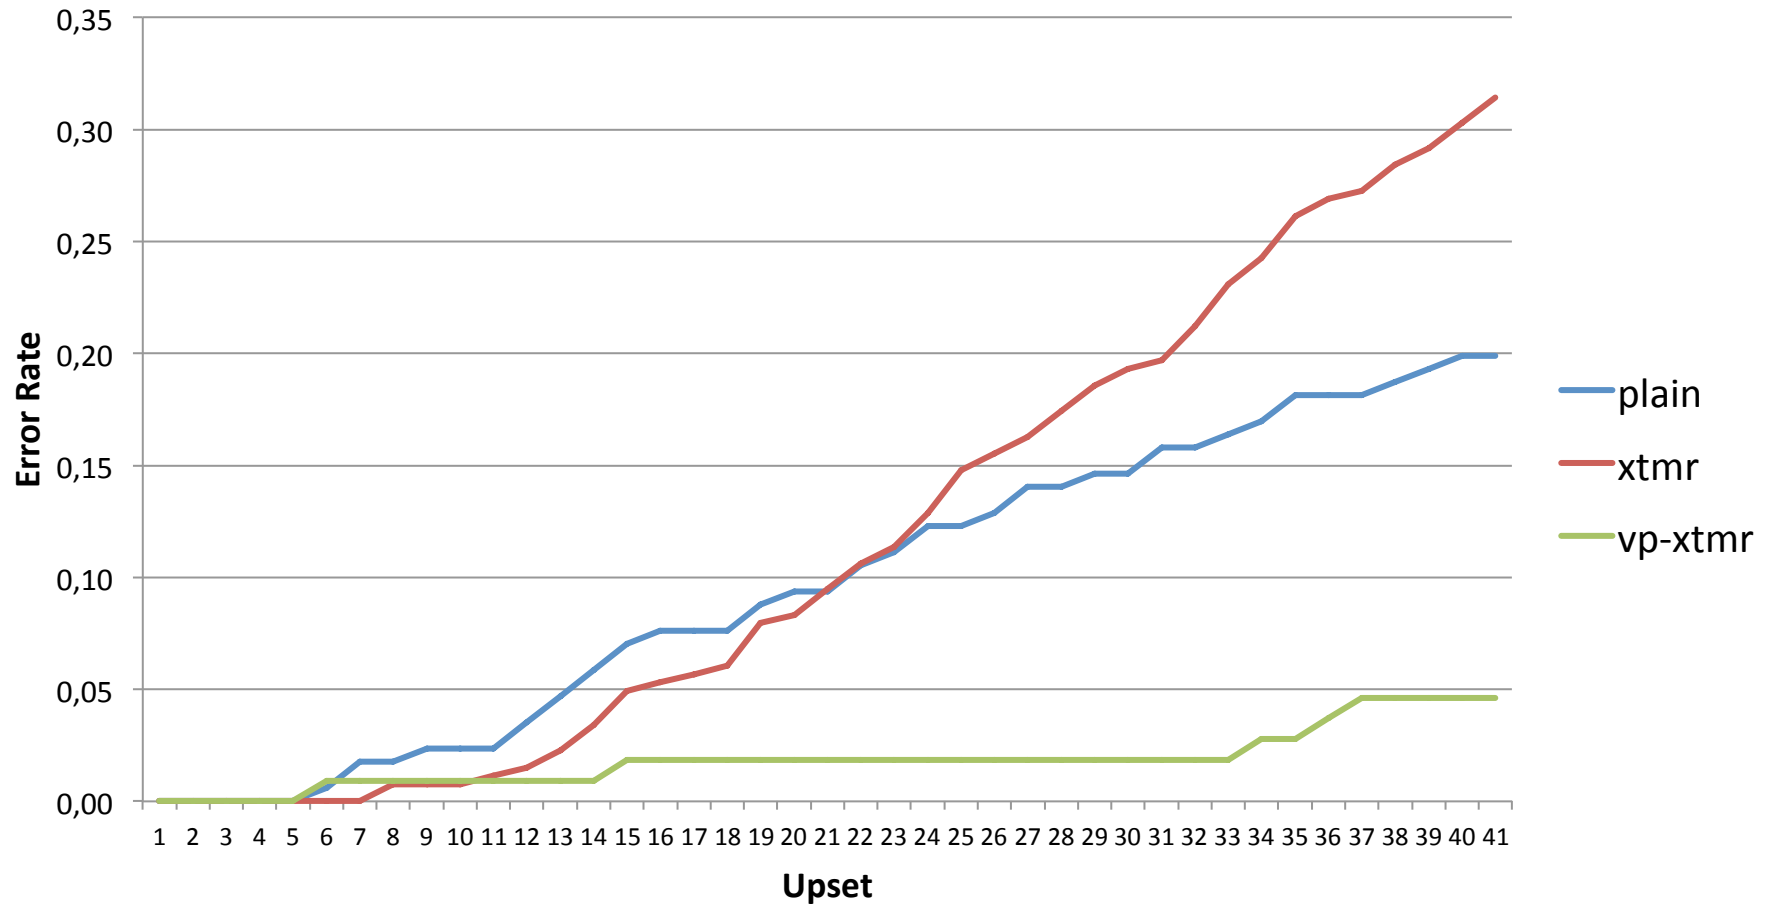
breakeven point
